HOUSATONIC RIVER BASIN
GOSHEN, CONNECTICUT

WOODRIDGE LAKE DAM CT 00452

PHASE I INSPECTION REPORT NATIONAL DAM INSPECTION PROGRAM

AUGUST, 1979

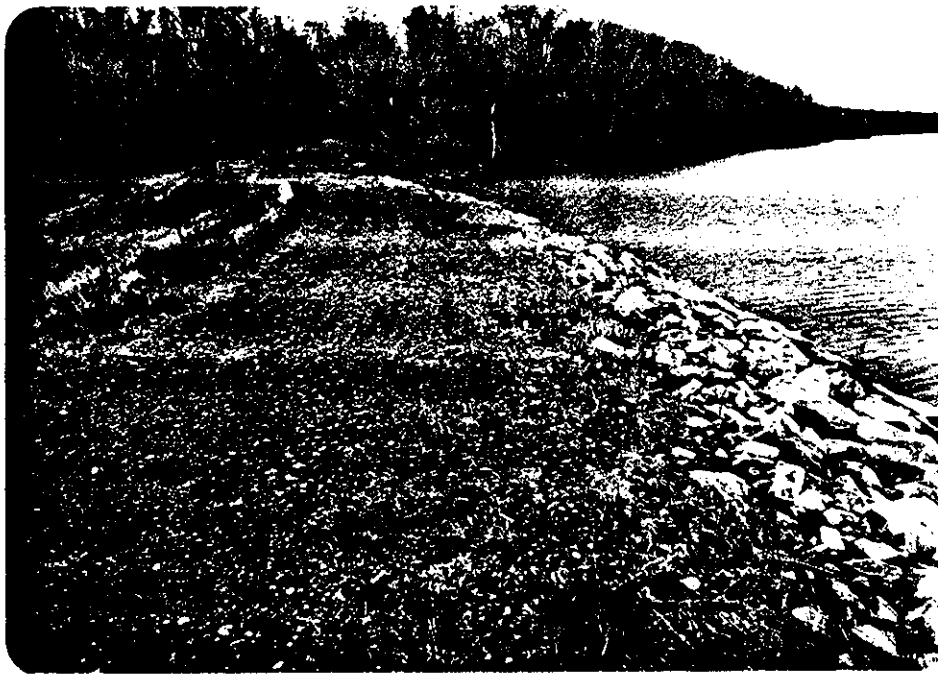
Crest - The 14 foot wide crest of the main embankment is gravel and grass covered (Photo 1). The 180+ foot long left embankment (left side of the dam from the spillway) has a grass cover only (Photo 2). No cracks or misalignment of the crest was observed. Several young trees are located on the top of the left embankment.

Upstream Slope - The upstream slope inclination is 2 horizontal to 1 vertical, and protection of the slope is 18 inch thick dumped rock riprap placed between the dam crest and elevation 1135. The riprap is generally in very good condition (Photo 1). The upstream slope of the left embankment has a grass cover (Photo 2) on which an erosion spot of 15+ feet by 12+ feet and 1 to 2 feet in depth was found. The origin of the erosion is probably wave action.

PHOTO 1 - Top and upstream slope riprap of main embankment.

6. The eroded area on the upstream face of the left embankment should be repaired, and riprap placed to eliminate further erosion.
7. Cracks on concrete surfaces of the spillway training walls should be repaired.

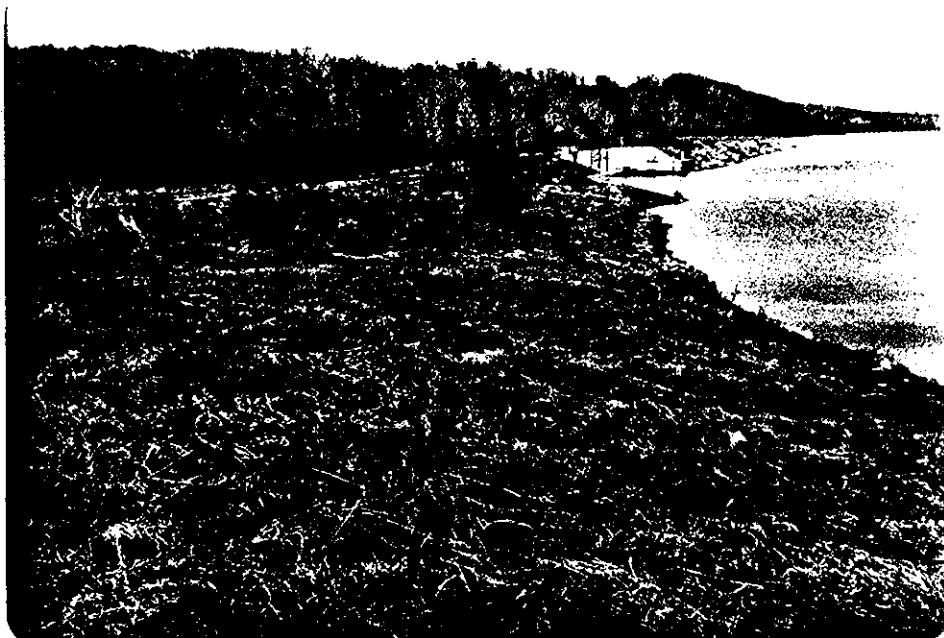
PHOTO 2 - Top and upstream slope of left embankment.

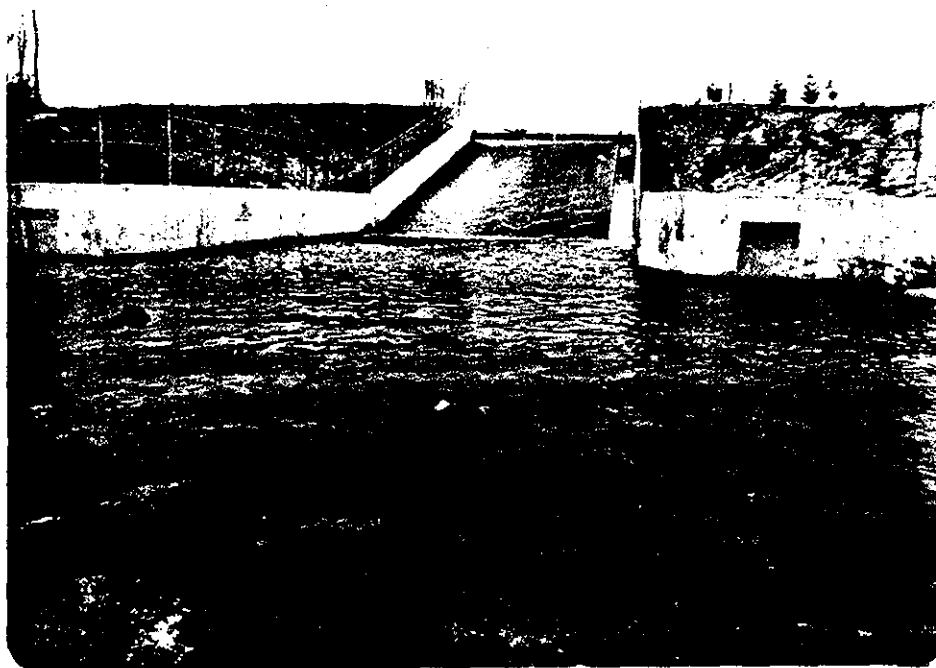
The spillway is generally in good condition (Photo 6). The concrete shows no substantial deterioration, misalignment of the construction joints, or seepage spots. Cracks were discovered in the construction joints and corners of the training walls, and range in size from 1/32 to 5/32 inches.

PHOTO 6 - Concrete spillway chute and dumped rock exit channel

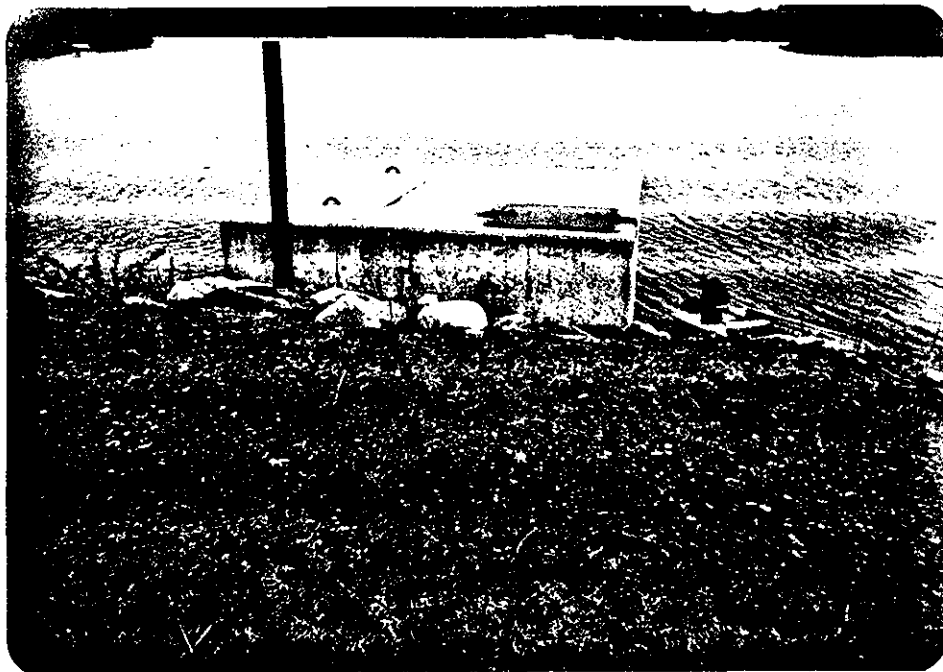
c. Appurtenant Structures - The concrete valve chamber (Photo 7), the concrete low level outlet headwall, and the low level diversion channel (photo 8) are in good condition. No cracking or spalling of the concrete structures, or obstructions in the channel were observed.

PHOTO 7 - Concrete valve chamber.

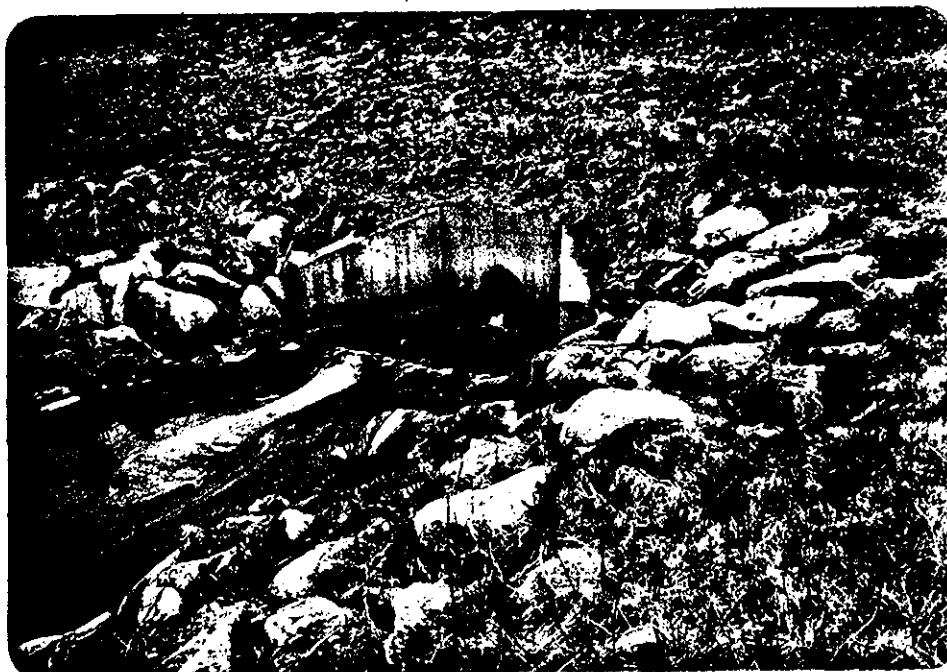
PHOTO 8 - Concrete low level outlet and dumped rock diversion channel.

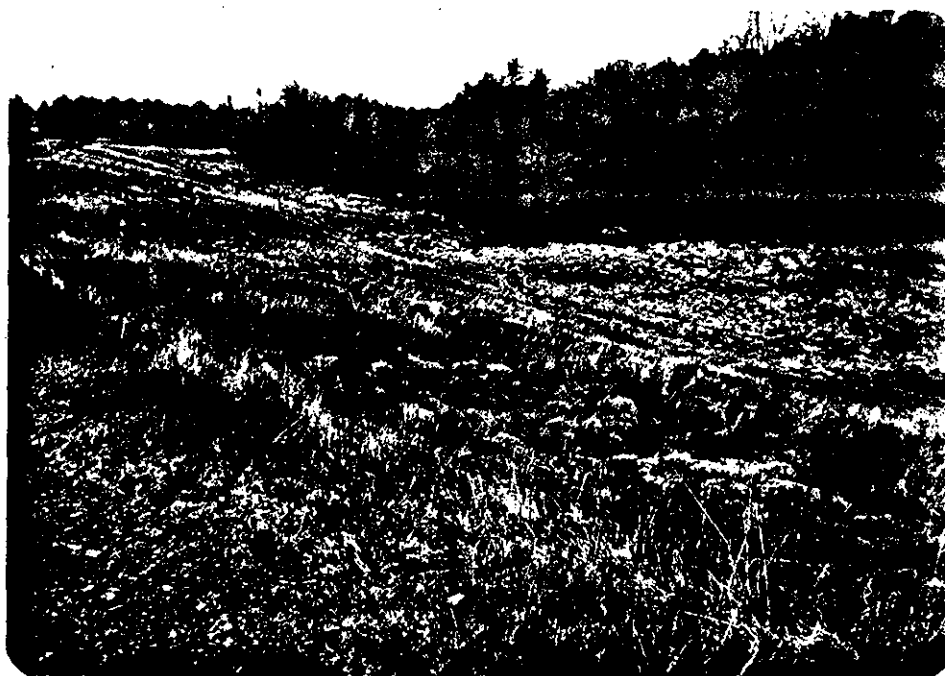
PHOTO 9 - Downstream slope. Note outlet at center of photograph.
